DALTON LAKE DAM

STE. GENEVIEVE COUNTY, MISSOURI

PHASE 1 INSPECTION REPORT NATIONAL DAM SAFETY PROGRAM

DECEMBER 1978

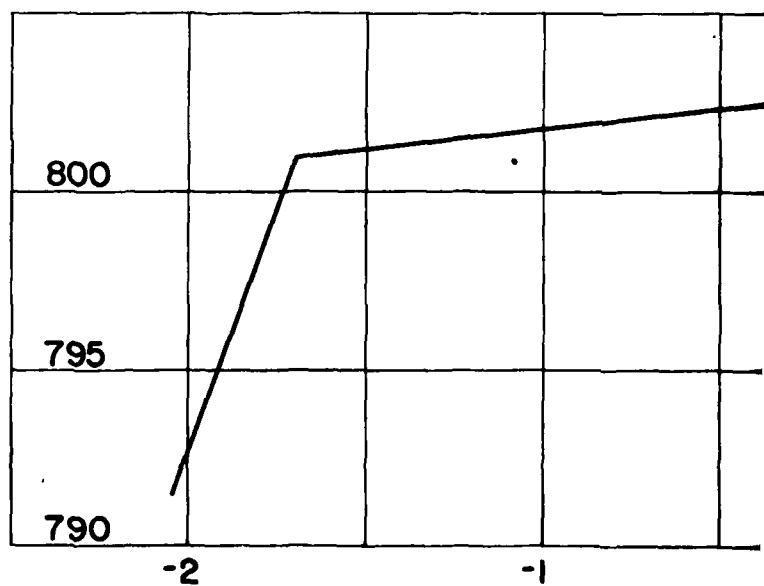
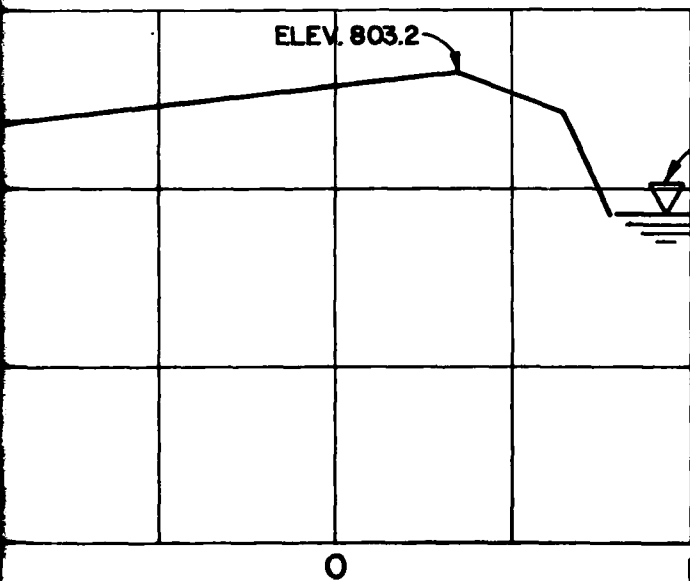
PLATE 2

The crest of the dam was found to be approximately 2 feet lower near the left abutment than in the area adjacent to the spillway. (The low point of the dam is approximately 2 feet higher than the spillway crest.) As a result, the capacity of the spillway to discharge lake outflow without overtopping the dam is reduced.

d. Earth Spillway. The spillway section is an excavated earth section that contains a considerable quantity of gravel which appears to exist naturally in the soil. The entire spillway channel is unprotected (see Photo 5) and some erosion of the bottom was noticed. A profile of the spillway channel through the control section is shown on Plate 2.
